## Foreword to representatives and public people

### *The Saint-Pardoux, a river to protect*

### *Aim of the study*

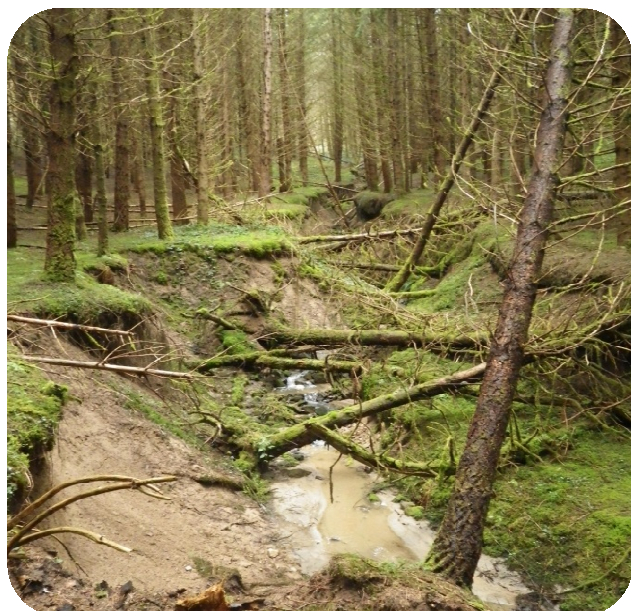
*Consequences of resinous plantation on the Saint-Pardoux.*

- its root systems cannot maintain the stability of the edges and encourage the erosion (trees falling in the minor riverbed, creation of logjam),
- planted in high quantity, these trees cause shadow on the river, limiting the development of the fauna and the flora,
- the plant litter doesn't decompose easily and accumulates in the riverbed,
- the use of mono-species and regular configuration in plantation, prevent the environment ability to resist perturbations (floods, tempests, fires, invasive species) and the limit the development other vegetation stratum (herbaceous, bushy species, tree-filled species).

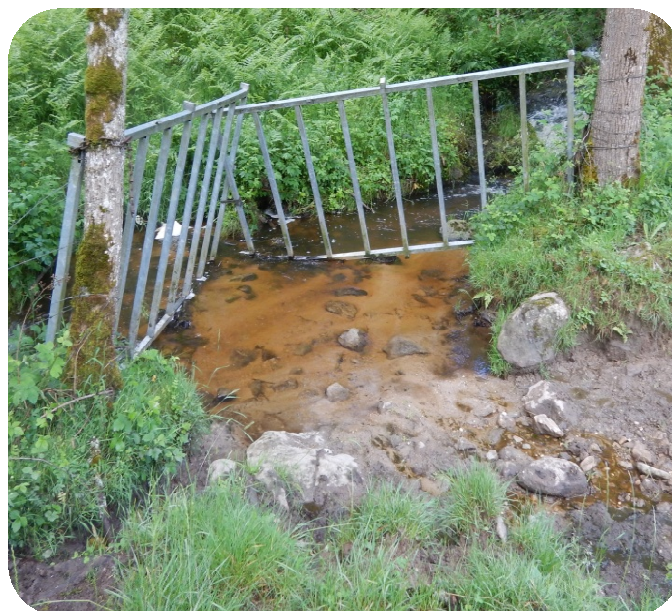
*Consequences of the bovine stamping on the Saint-Pardoux.*

Today, the Saint-Pardoux is threatened by quality issues: from one side, the bovine stamping, which leads to the deterioration of the riverbed and brings organic substances in the water; from the other side, the conifer plantation on the river's edge which is modifying distinctly the morphology of the Saint-Pardoux and the quality of the water.

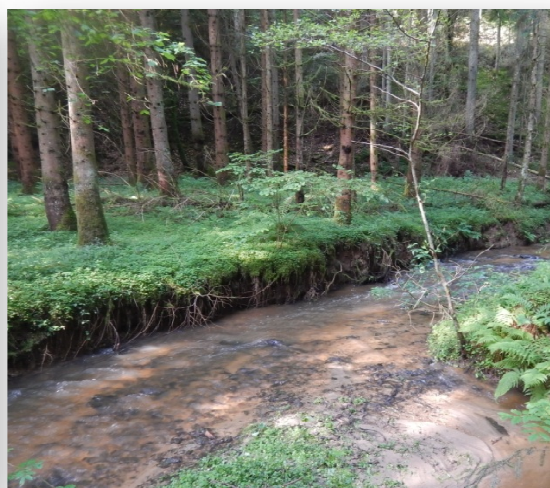
*On the left, the reference station, on the right, the resinous station.*

We have identified two sectors called "stations" located on the Saint-Pardoux. The first one has been defined in a non-conifers area possessing specific river vegetation (alder, ash, etc.). This station was declared "reference station", which means the environment in this location is identical to the environment we should find normally. The second station has been chosen downstream compared to the previous one, and was located inside an area impacted by the resinous plantations.

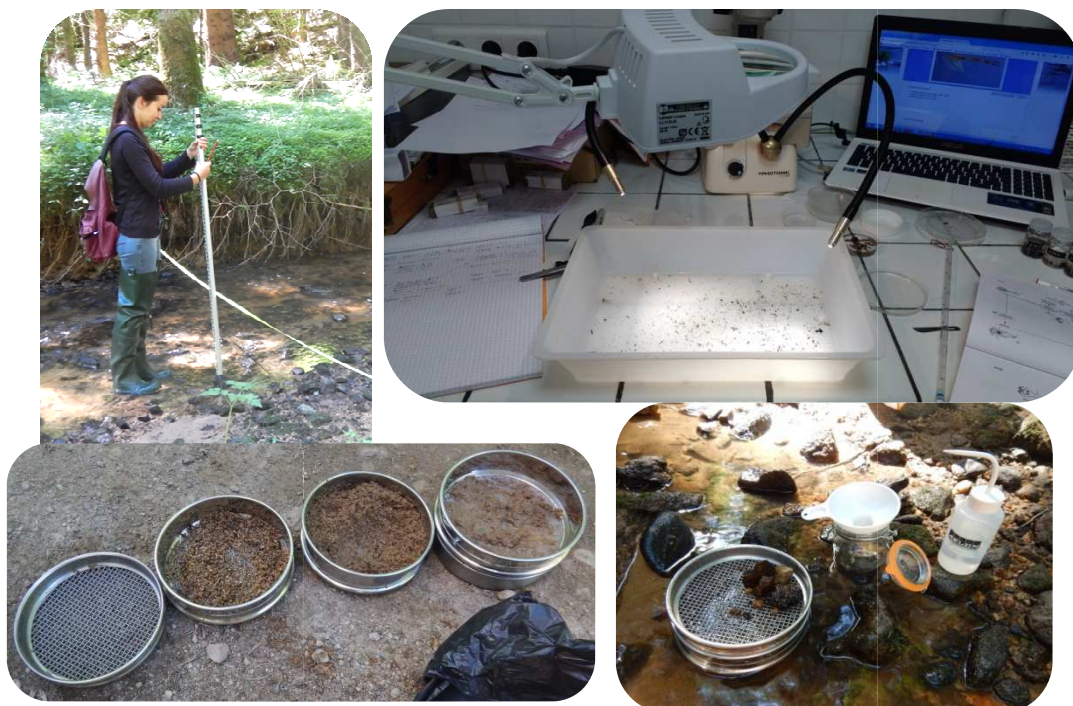
*Some examples of the river analysis performed on the Saint-Pardoux*

The follow-up protocol defines two measures: 1) a geomorphology monitoring, including the analysis of the geometry of the riverbed, flow facies, sediments transportation, riparian vegetation and the state of the river edges; 2) a biologic diagnostic studying the fauna found in the bottom of the river (benthic macro invertebrates). The following indicators have been used: SYRAH, CARHYCE, IAM, IBG-DCE and sediment traps.
