Organisme d'accueil : Cranfield Water Science Institute - Cranfield University

Geomorphic change and its impact on
floodplain vegetation in a lowland river system
(River Ingrebourne, Ingrebourne Marshes
SSSI)

DROUET Lucille

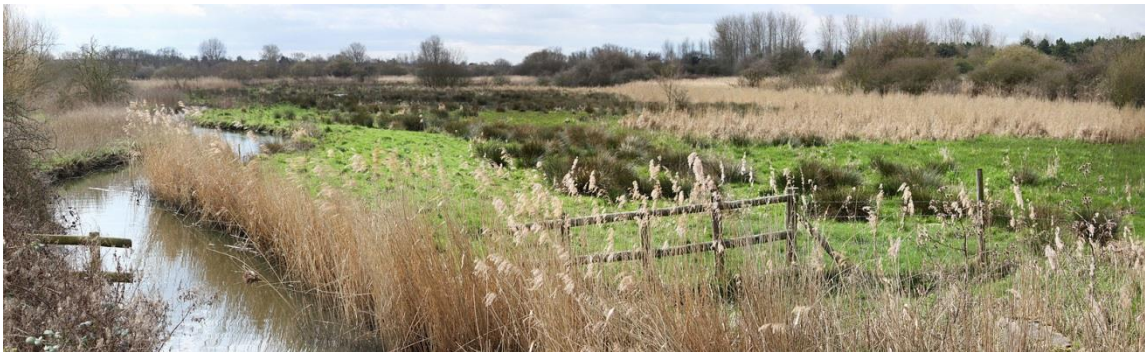
The river flowing in the middle of the fen habitat impacts the ecology of the system. (Figure 2)

Figure 2: picture of the Ingrebourne river into the fen habitat, wikimedia

For example a change in the morphology of the river, because of excessive sedimentation or a channel choked with plants, increases the water level in the channel, and impacts the habitat.

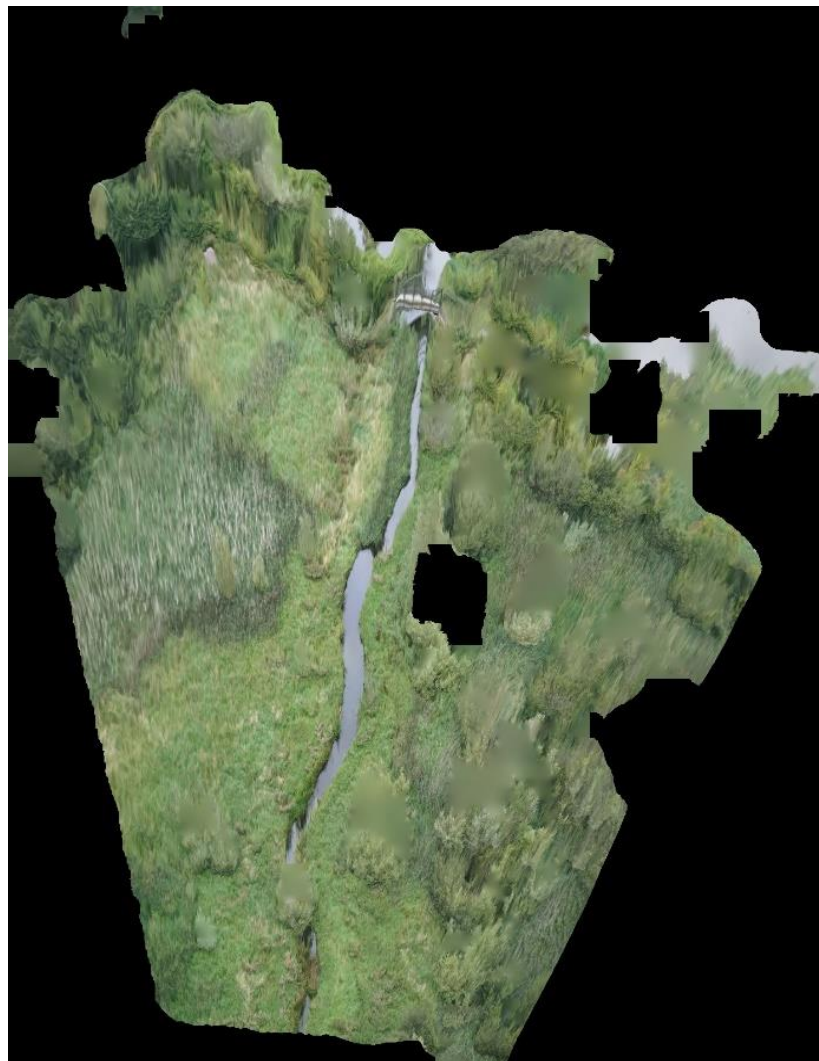
Figure 6: orthophoto of the first area of the marshes

Normally, we should map all the marshes zones but the UAV photos have different angles, distance, localisation... and it was impossible to create orthophoto for all the marshes area. An example of an orthophoto obtained is presented beside (Figure 6):

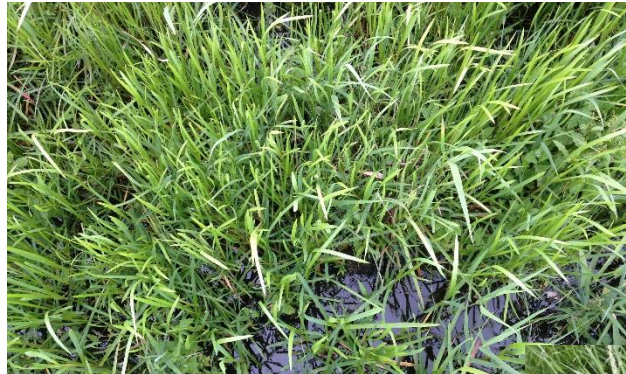
Figure 7: a glyceria maxima stand taken in a vertical photo

Next, we would like to be able to run a supervised classification in these photos. (Figure 7 to 11) First, the method was to go on the field and identify single species stand. These identified stands allow to calibrate the classification.

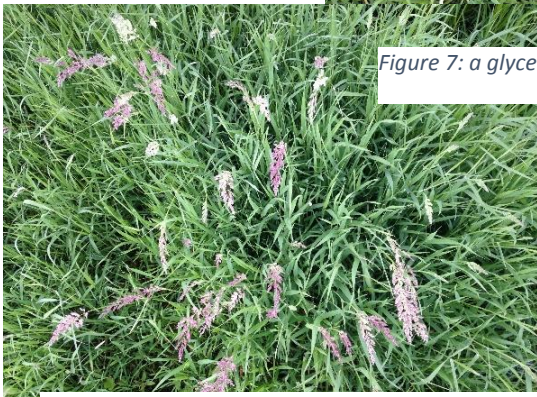
Figure 10: a phalaris stand taken in a vertical photo

We observe that *Phalaris* stand can have purple spike or yellow-white spike. We observe also that there are two types of *Phragmites* stands: young that are green blade and old that are browner.

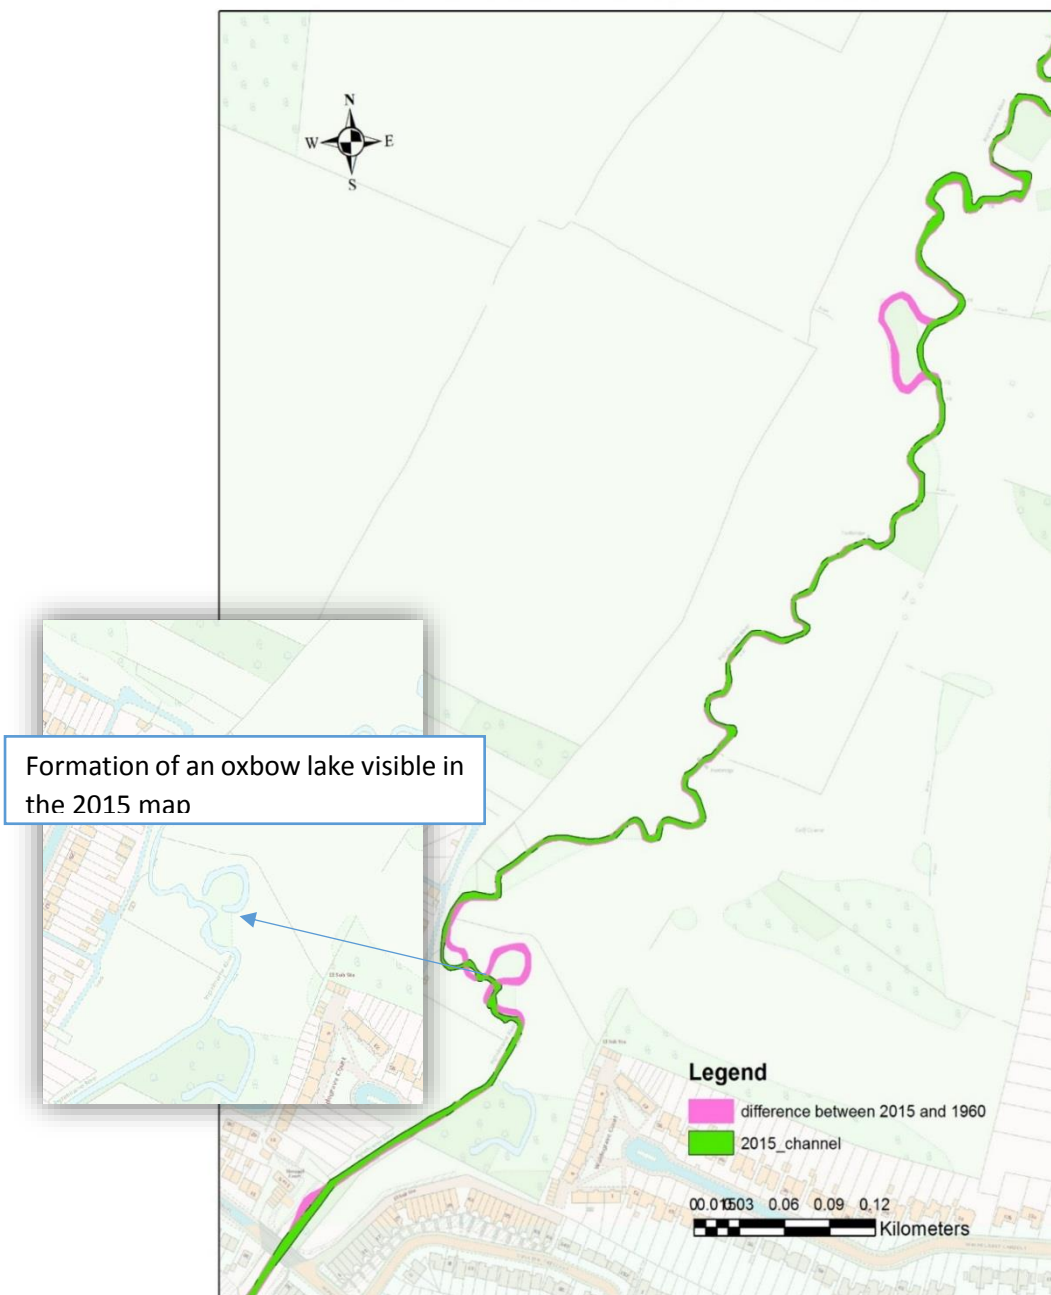
Figure 28: map of the cut off meanders upstream of the marshes and a zoom in the oxbow lake, basemap : 2015 Mastermap 1_1000

In some area, the channel shape has changed significantly, as we can see in the below Figure 28 in Upminster, 5km upstream of the marshes.

This type of readjustment is happening when the river has more sediment discharge (Q_s) than water discharge (Q), therefore the system is unbalanced. Sediment are deposited and plugs are created. The river overflows at the beginning of the meander. The meander is cut with the formation of another arm, with a bigger slope, that connect the outset and the exit of the meander. This lead to the formation of an oxbow lake, the 2 ends of the former arm will be obstructed by the sediment deposition. This is a sign that management practises in the catchment have change the river dynamic, and could have consequences in the fen habitat itself.
