# Rapport de stage individuel

## Study of a constricted vegetation-less meander river

## **Study of a constricted vegetation-less meander river**

Experiment in flume

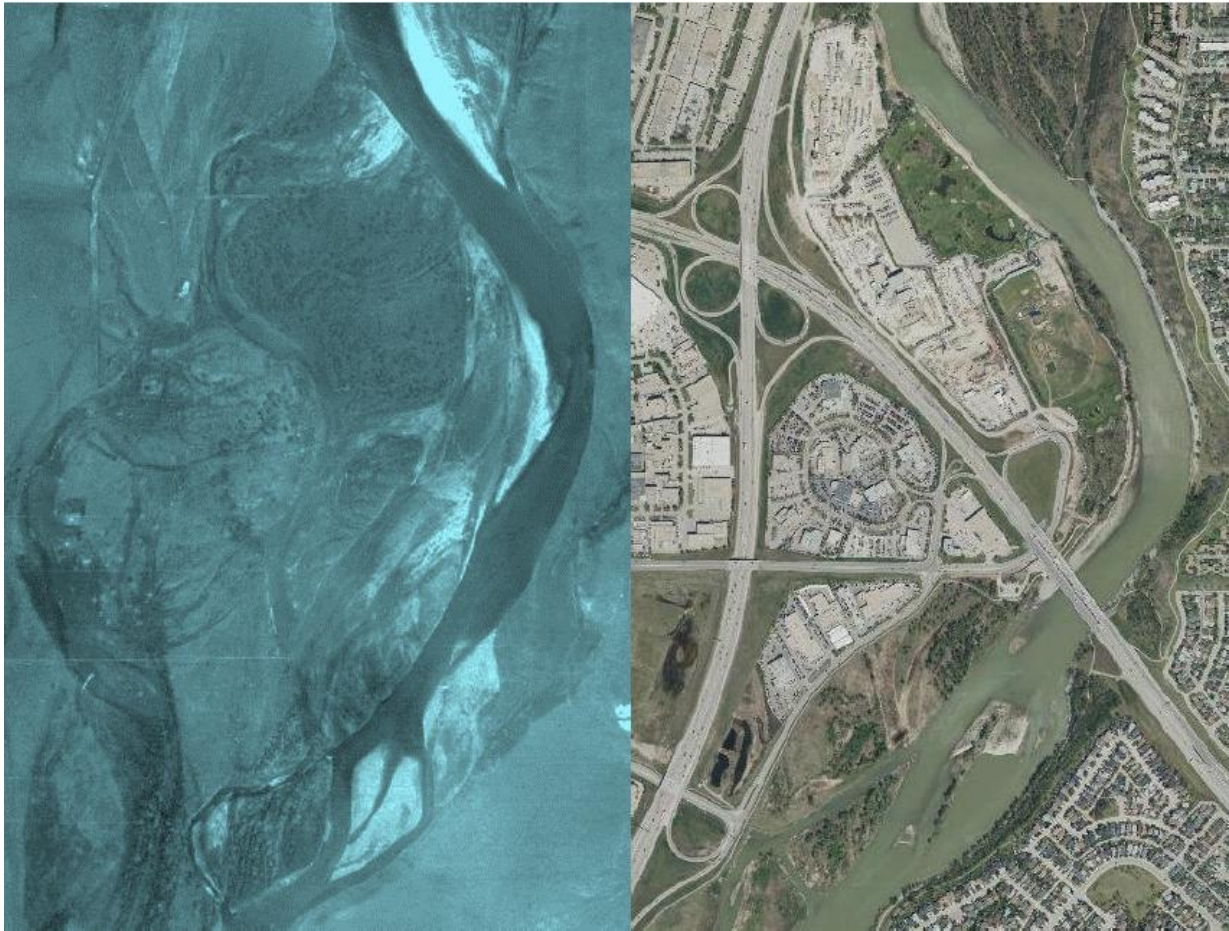
*Figure 1: Aerial imagery from 1924 and 2020 of the Bow River flood plain near Heritage Meadows. Note the complex diversity of riverine habitat that existed prior to development. These types of habitats can no longer be created here due to the river being constricted*

The Bow River is a meander river located in Calgary, Alberta, Canada. Prior to the construction of dams, bank stabilization and the lack of significant floods for eighty years, the river was characterised by complex forms and morphology with a multi-threaded channel and several islands. Today, the channel through and downstream of Calgary is simplified and relatively static (Figure 1). In response, the riverbanks have become densely vegetated mainly by poplars and willows. Eventually, the erosion pattern is highly modified, due to the disappearance of unstable point bars (Rood and Kaluthoda, 2017).

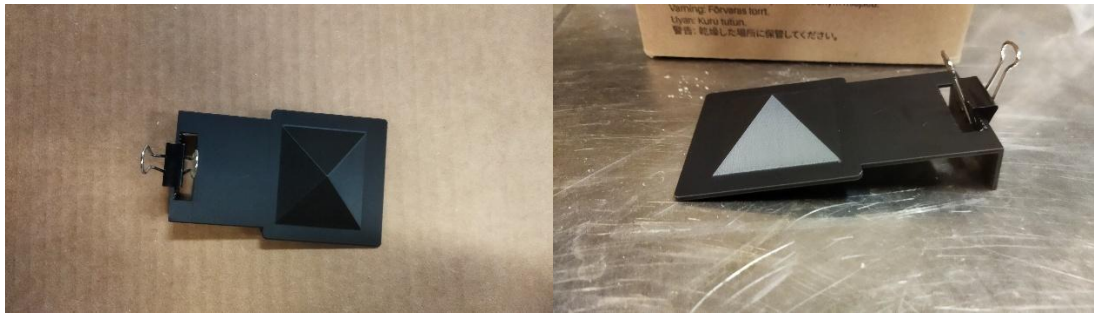
*Figure 7: Photograph of a 3D marker*

A series of 3D markers was printed and installed on the walls of the flume with paper clips (Figure 7). To make sure the markers were put in the exact same place every time, marks were made on the PVC walls. This configuration allowed to remove them easily for when we would take the pictures. The 3D camera has an elevation accuracy of 0.05 mm and can scan from a height between 500 and 1000 mm.

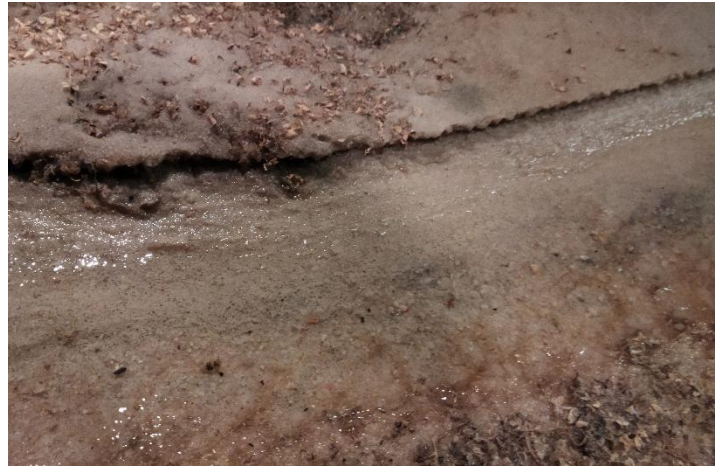
*Figure 21: Photograph of the left bank of the flume after the running of the sequence of floods*

Figure 21 shows a close-up of the left bank erosion observed after the floods.
